# Marina and Boatyard Indoor Rack Storage Sprinkler Protection

*Literature and Data Review*

Daniel J. O'Connor, PE  
Thomas Gardner, PE  
**Schirmer Engineering**

THE  
FIRE PROTECTION  
RESEARCH FOUNDATION

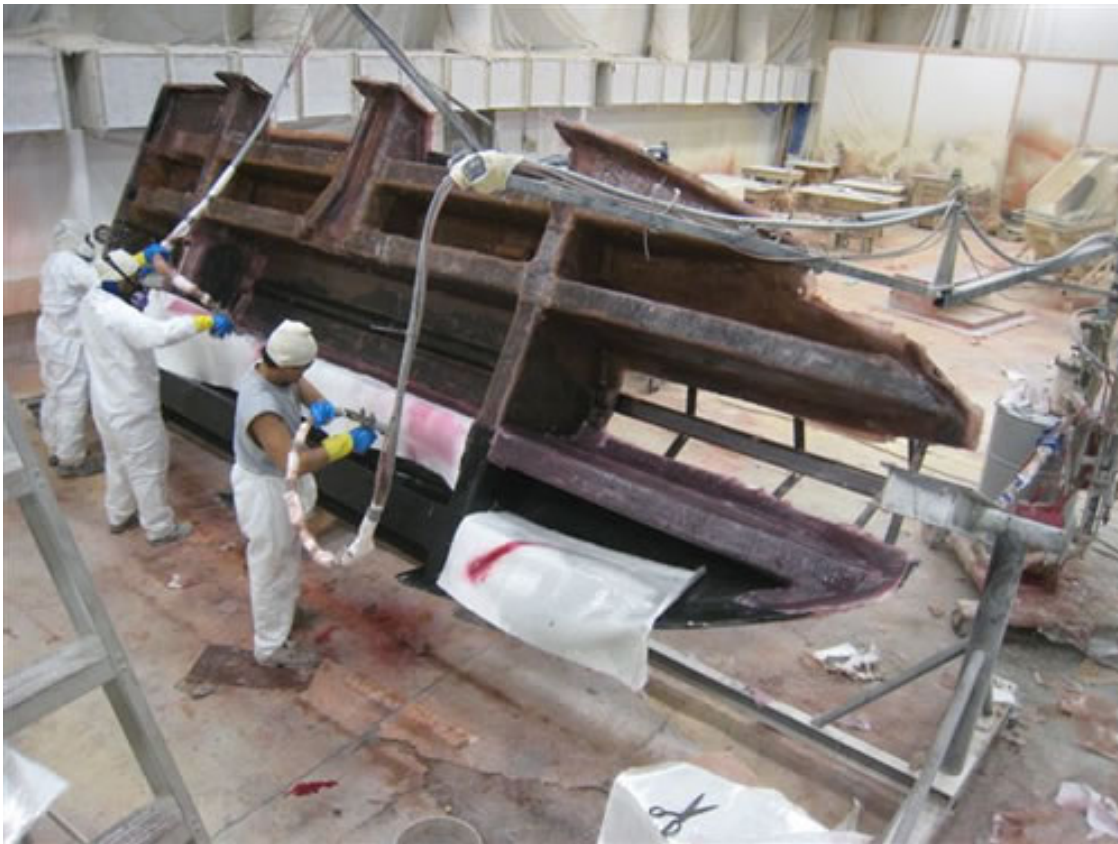
**Figure 2. Hull Structural Grid System**

Beyond the choice of plating arrangement, the hull internal support structure will vary dramatically from builder to builder. The need to incorporate floatation foam in boats under 20 feet<sup>5</sup> will often influence internal structure. Many builders use structural grid systems that are created on specialized molds and subsequently bonded to the laminated hull. Figure 2 shows an example of a hull structural grid system being fabricated.

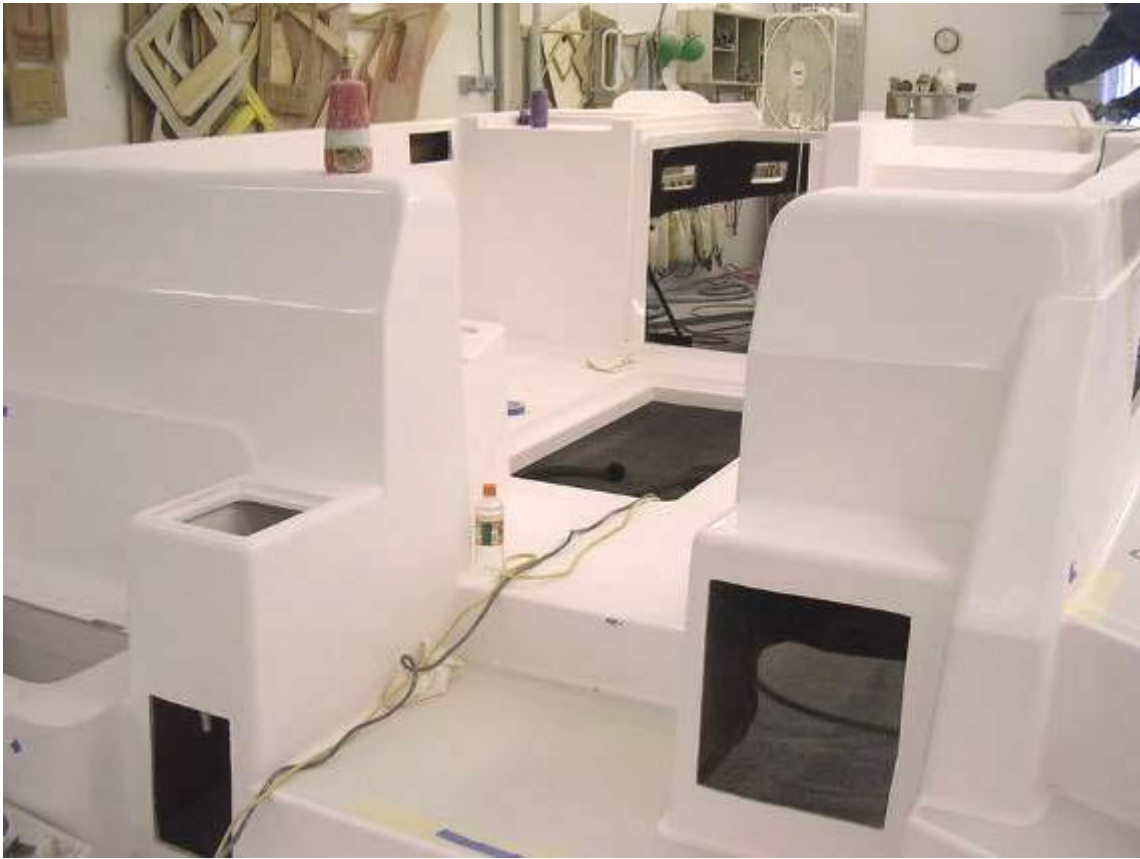
**Figure 3. Complex Deck Part Built by Sabre Yachts**

While smaller boats have relatively planar deck structures, larger boats feature complex geometry to maximize the layout and exploit the capability of composite construction. Figure 3 is an example of a complex deck structure designed to maximize interior space.

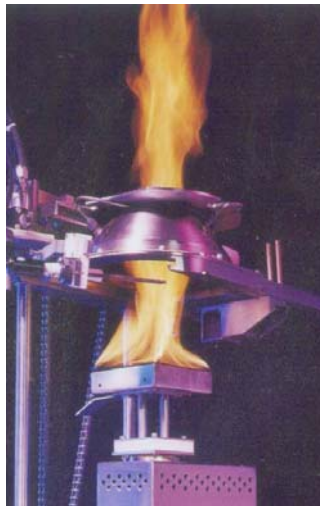
Figure 9. Cone Calorimeter

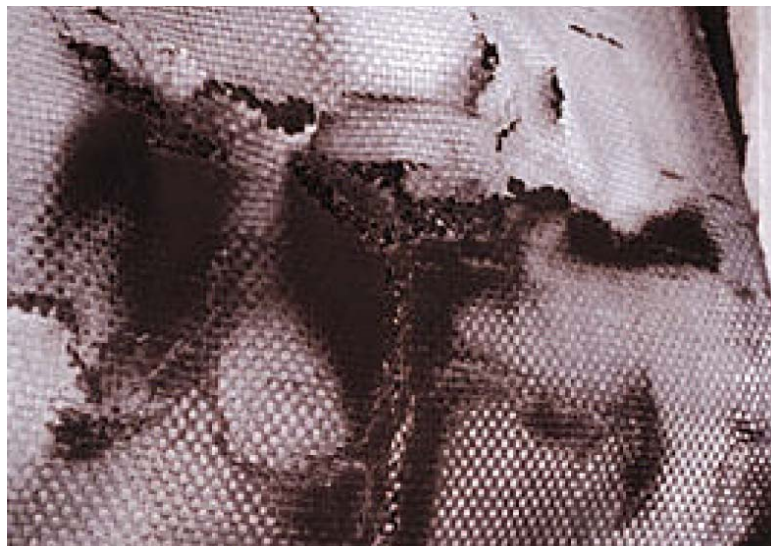
**Figure 10. Composite Laminate after Structural Integrity Fire Test**

Burn-through resistance is not a paramount parameter when considering small boats involved in marina fires. However, structural integrity can be an issue if we are concerned about boats falling apart during fires and creating hazards for firefighters. Figure 10 shows a composite laminate system after a structural integrity fire test, exhibiting near complete pyrolysis of the laminate matrix resin system.

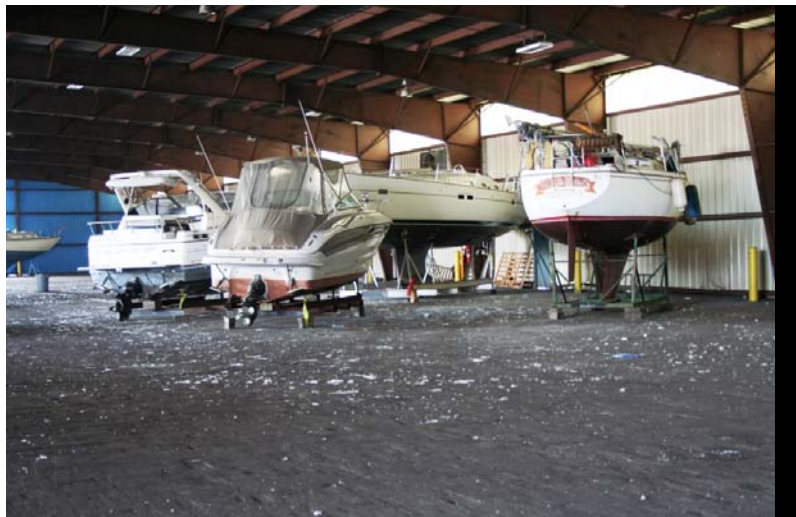
**Figure 11**

The above photographs, Figures 11-12, show two typical one-story indoor boat storage facilities. In the winter these warehouses would be filled with boats nested together to allow for maximum utilization of the storage space. The facility in Figure 12 is heated as evidenced by the heating equipment seen along the wall. These facilities can accommodate a wide range of boats from fishing boats to cabin cruisers and sailboats with their masts removed.

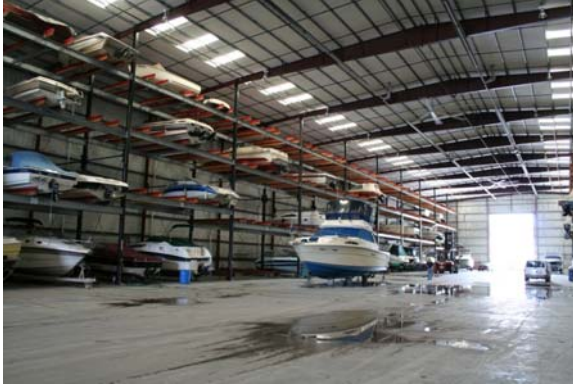
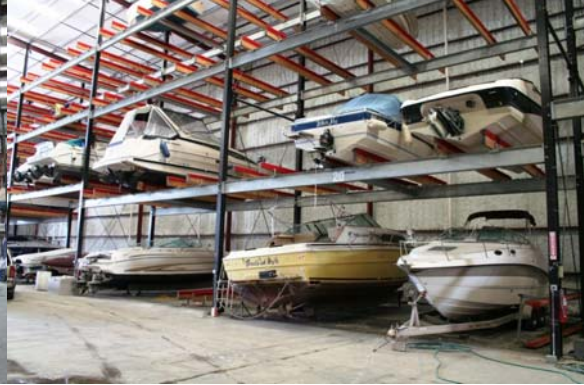
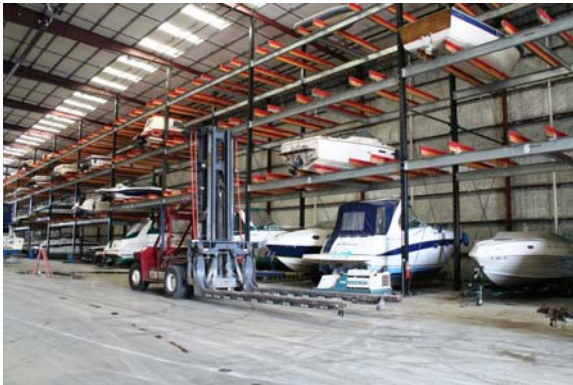
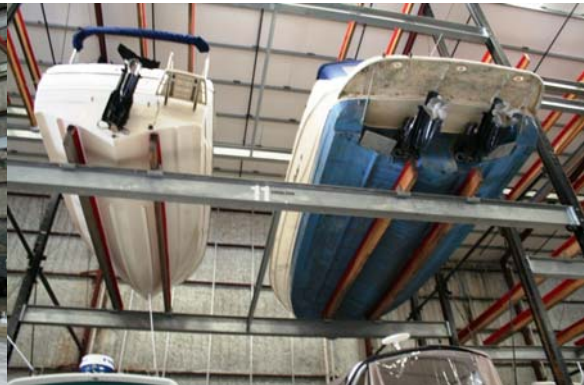
Figures (photographs) 13-16 illustrate the conditions typically encountered in a rack storage or dry stack boat facility. In this case there are four levels of boats, the lowest level being loaded by simple rolling boats on their trailers into position. The steel structural system supports both the shelf beams and the building's roof truss system. The two rack systems in this building are separated by a distance of approximately 60 feet. Figure 15 shows the lift truck equipment used to locate boats into the upper racks. Figure 16 illustrates the method of support used; in this case carpet-covered wood joists are used to support the boats. The steel brackets that hold the wood joists are designed to support the weight of different boat designs.

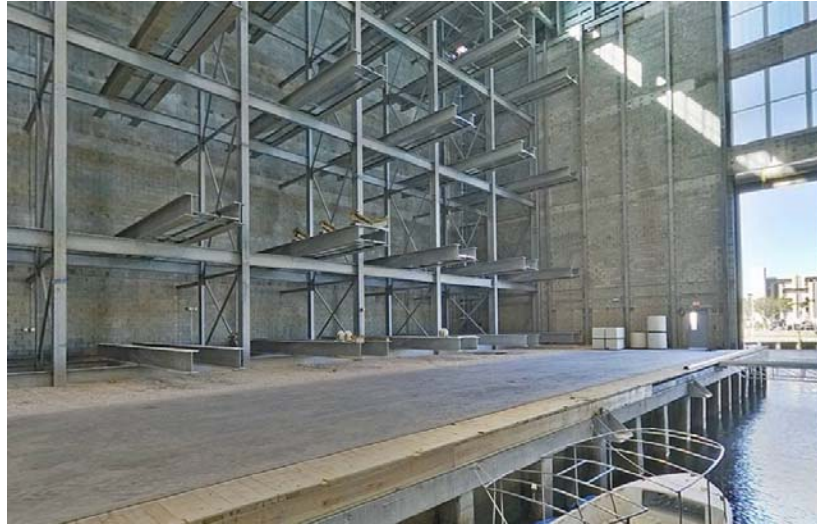
**Figure 17**

Figure 17 depicts the rack storage structural system and water channel of a fully automated dry stack storage facility. In this facility the steel columns supports both the racks structure and the steel roof trusses. Figure 18 illustrates the automated crane operating to place a 36 foot boat into a reserved rack storage location. These automated facilities required a large empty volume for the crane to operate and consequently there exists a large physical separation between the two vertical racks of storage.

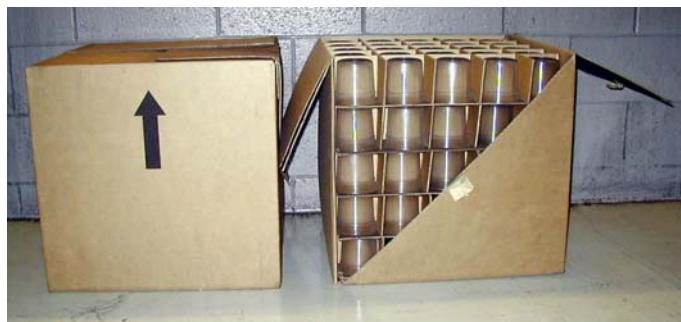
**Figure 21.** Prototypical Class A Commodity, 16 oz. polystyrene plastic jars in corrugated carton

The assumption that rack storage of boats is analogous to rack storage of Group A Plastics on solid shelves raises some questions given that a side-by-side visual comparison the storage arrays are clearly different in many respects. Figures 21, 22 and 23 illustrate a typical rack storage fuel array conditions used for sprinkler system fire testing. The boxes as shown in Figure 21 contain the standard Group A plastic commodity (16 oz. polystyrene plastic jars) used for validating Group A plastics sprinkler design criteria. Figures 24 and 25 depict a typical boat rack storage facility.

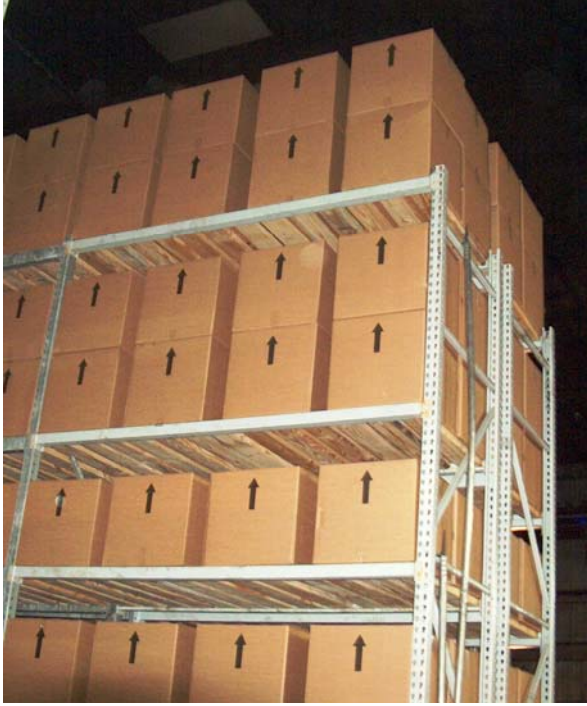
**Figure 22.** Example of Shelf Storage Array

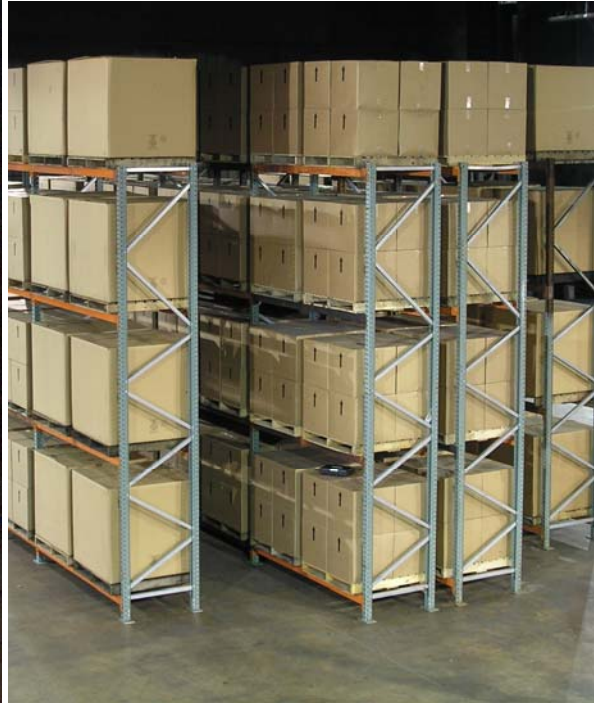
**Figure 23.** Example Fire Test Rack Storage Array

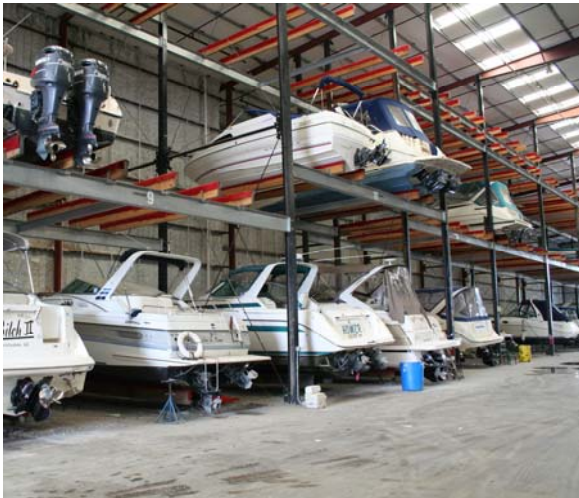
**Figure 24.** Boat Storage Array

In addition to the clear differences apparent from a visual perspective there are also a variety of technical differences and practical issues regarding the installation of sprinklers in a dry stack boat storage facility. Several observations and comparisons are provided in Table 10 comparing the typical Group A plastics rack storage array with the boat storage array shown in the above figures.

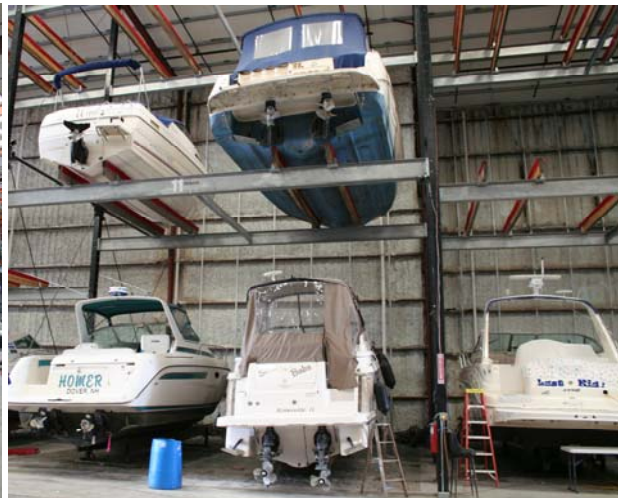
**Figure 25.** Rack Storage of Boats Showing Spacing
